Dutch East India Company Shipbuilding

THE ARCHAEOLOGICAL STUDY OF
BATAVIA AND OTHER SEVENTEENTH-
CENTURY VOC SHIPS

Wendy van Duivenvoorde

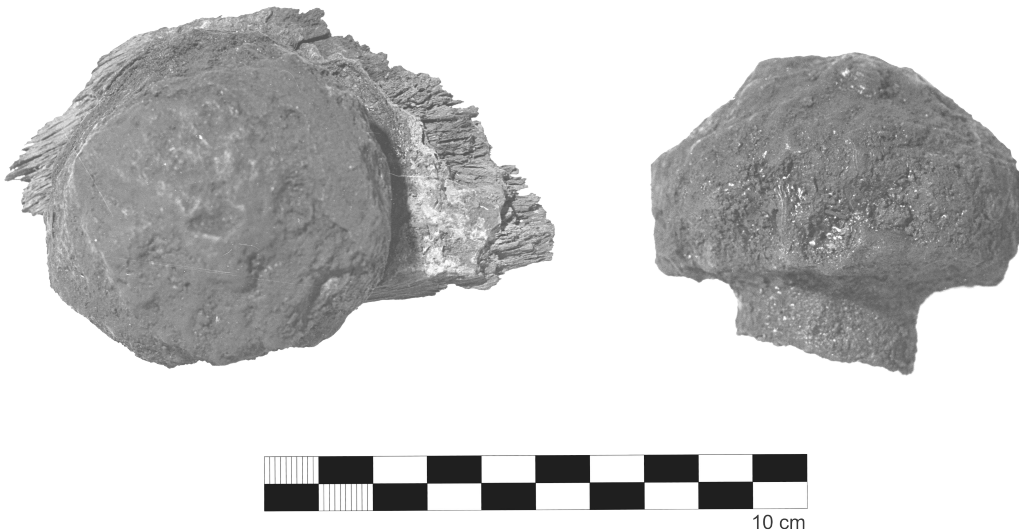
FIGURE 4-80.
Top view (with wood
attached) and side view
of replica from iron
bolt concretion, BAT
3550 R. Photographs by
Patrick Baker, Western
Australian Museum
(MA0241-32 and
MA0241-33).

The largest fasteners used for *Batavia*'s construction are iron bolts. They were mainly used to secure riders to the ceiling, frames, and hull planking. No riders have been preserved, but the bolt holes to fasten them are still present in other timbers. Round bolt holes are primarily found in *Batavia*'s second futtocks, indicating that the riders had the same average room and space of 41.4 cm. These bolts could easily have measured more than 60 cm in length, considering *Batavia*'s planking thickness, molded frame dimension, and ceiling planking thickness. The shanks of the bolts were round in section with consistent diameters of approximately 2 cm. They were inserted from the exterior of the hull where their large heads rested on the exterior of the hull planking. The bolt heads were roughly circular in section and peened at their tops (fig. 4-80). Generally, one or two bolts were used in each hull plank for every second futtock. The pine sheathing planks had cutouts to accommodate the large bolt heads. The diameter of the bolt heads seems to vary between 3 and 6.4 cm.

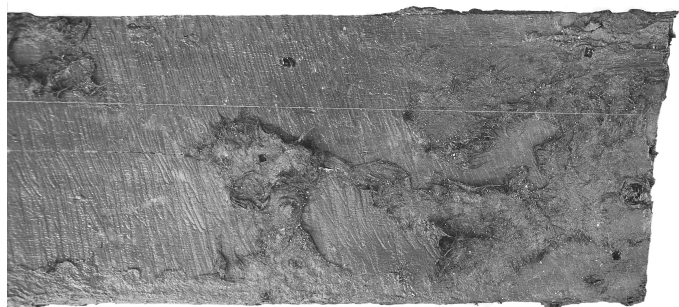
FIGURE 4-81.
Saw marks of framed pit saw
on interior surface of outer
hull planking, BAT 6106, strake
12. Photograph by Patrick
Baker, Western Australian
Museum (MA0188-26).

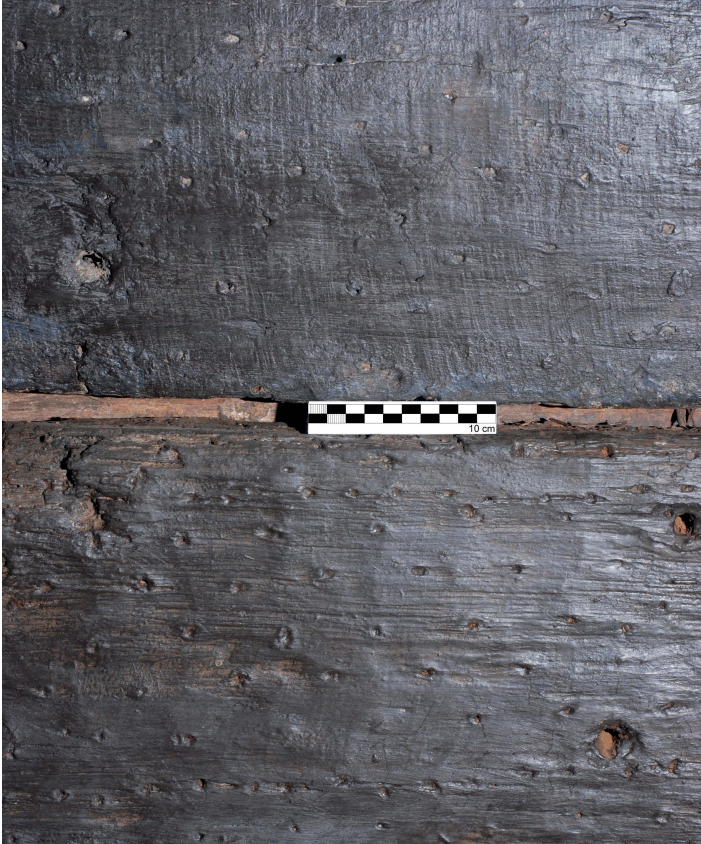
FIGURE 4-82.

Outer layer of hull planking with saw marks of framed pit saw on BAT 6078, strake 13 (*top*); and adze marks on BAT 6106, strake 12 (*bottom*). Photograph by Patrick Baker, Western Australian Museum.

Irregular saw marks seen in the excavation timber photographs and on the conserved hull planking clearly indicate that all planks were hand-sawn with a framed pit saw, not cut mechanically by a wind-driven sawmill (see figs. 4-36, 4-81, and 4-82). It is not surprising that the *Batavia* ship's timbers were sawn by hand, given the resistance of the Amsterdam hand-sawyers guilds in the early seventeenth century against the introduction of wind-driven sawmills.

Some hull planking surfaces show well-preserved saw marks, whereas others were deliberately smoothed by adzes (see fig. 4-82). The latter had their final shape established with adzes; adze marks are evident on all layers of hull planking (see figs. 4-36 and 4-82). The adze marks vary in size between 5.9 and 11.4 cm, with an average of 9.2 cm. The specifics of the adze and saw marks on the curved transom planking have been discussed previously. Tool marks also show that the futtocks were shaped and finished with adzes.

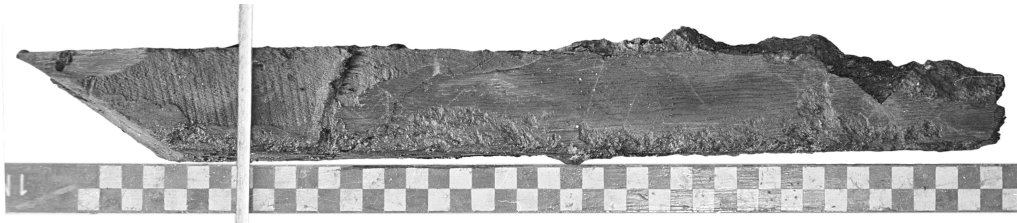
FIGURE 4-83.

Regular saw marks of framed pit saw on side of an inner transom plank, BAT 6414. Photograph by Patrick Baker, Western Australian Museum (MAO420-06).

Some of *Batavia*'s timbers seem to have regular saw cuts that can easily be misinterpreted as being sawn by a wind-driven sawmill (fig. 4-83). The distance between the saw cuts demonstrates that the timber was fed through the mill at a tempo that would create a cut of 5 to 9 mm. This tempo is beyond the capacity of a seventeenth-century sawmill. Furthermore, when the lines of the saw cuts are traced on paper and continued with a pencil, they are not parallel. They are, therefore, sawn by hand. A well-trained pit sawyer could saw smaller timbers easily with a speed that creates saw cuts with a distance between 5 and 9 mm.⁸⁷

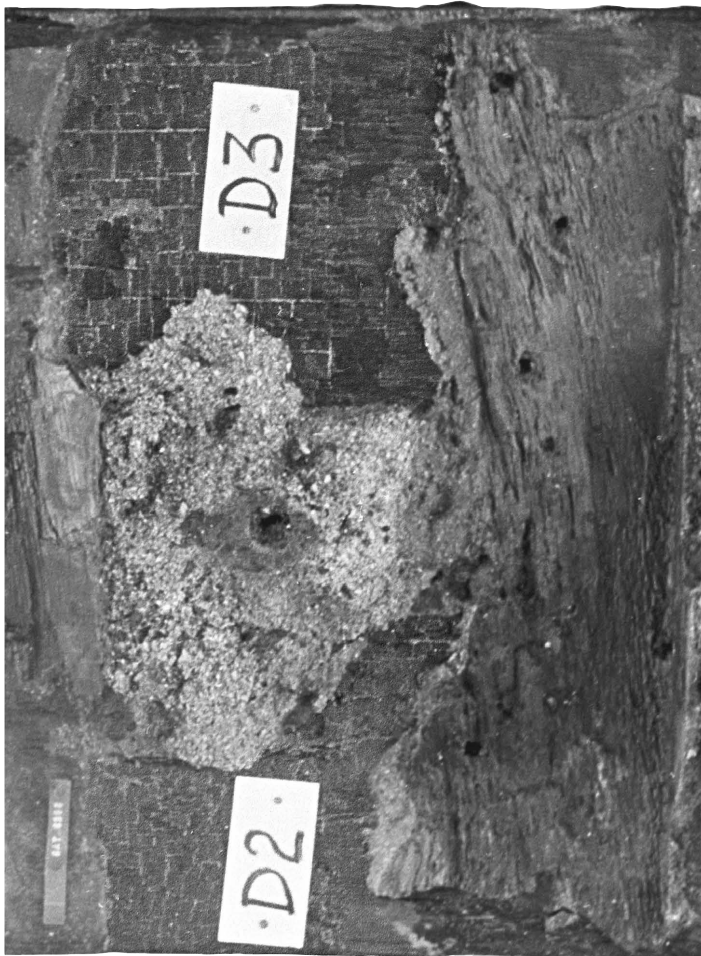
FIGURE 4-86.
Brown or soft rot around D2 and D3 labels on the interior surface of inner layer of hull planking, BAT 6395, strake 11, and BAT 6396, strake 12 (beneath frame C33, BAT 6328). Photograph by Patrick Baker, Western Australian Museum (MA0418-09).

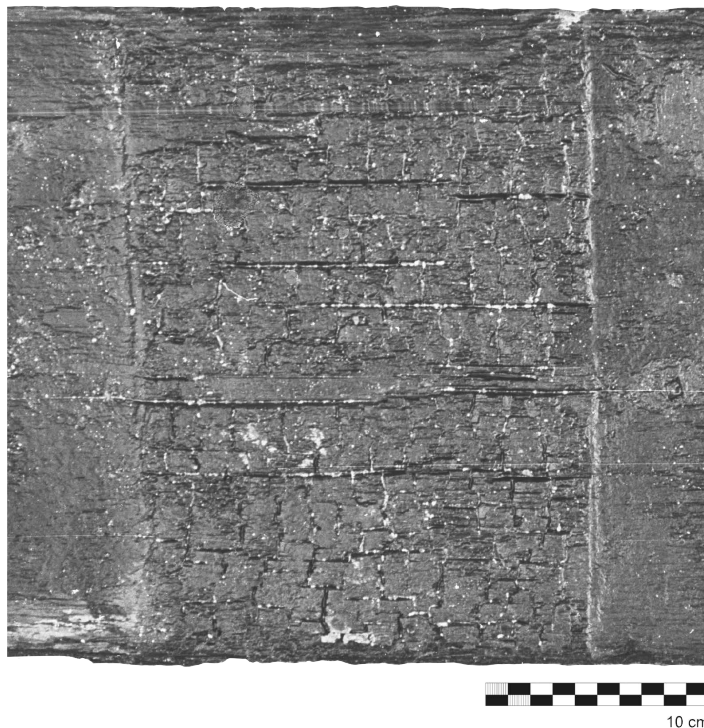
FIGURE 4-87.
Brown or soft rot on the
interior surface of inner layer
of hull planking, BAT 6097,
strake 12 (beneath frame
C20, BAT 6041/BAT 6065).
Photograph by Patrick Baker,
Western Australian Museum
(MA0186-06).

of brown rot (fig. 4-88a–c).⁹² It remains unclear, however, whether the damage was from brown rot or surface soft rot, which can also produce such dark stains. Micrographs of the exterior side of the sampled plank show a typical attack from bacteria but no fungal decay or cell compression (fig. 4-88d, e). Thus, the dark areas observed on *Batavia*'s hull timbers are more likely to be from brown or soft rot, which occurred within the ship's hull underneath the frames, than from charring (see fig. 4-87).

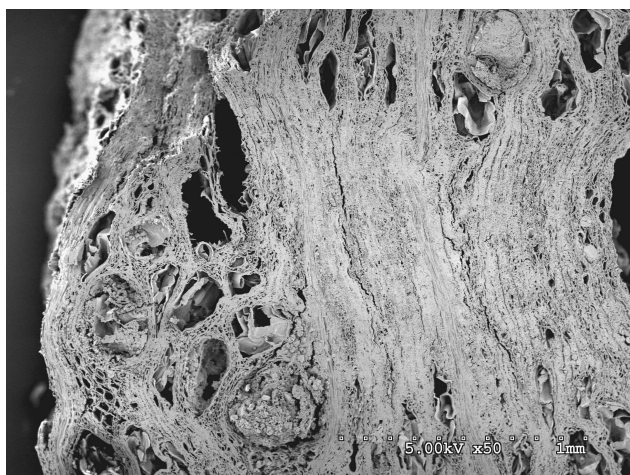
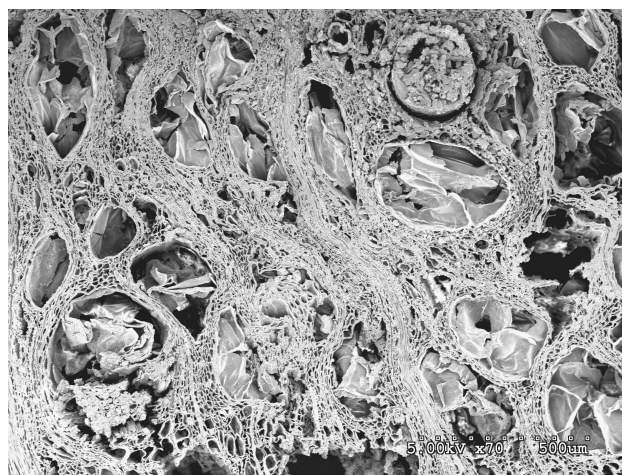
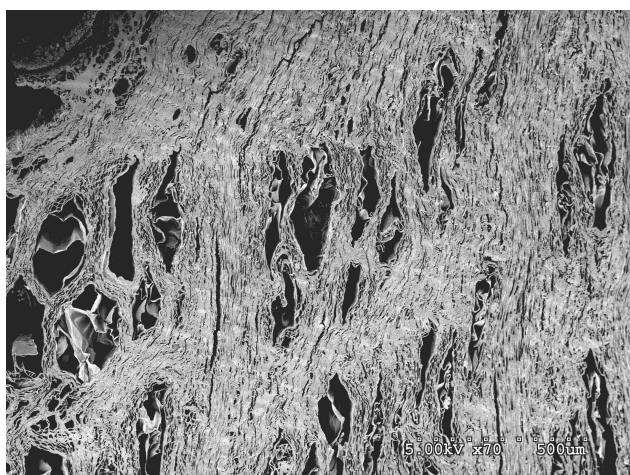
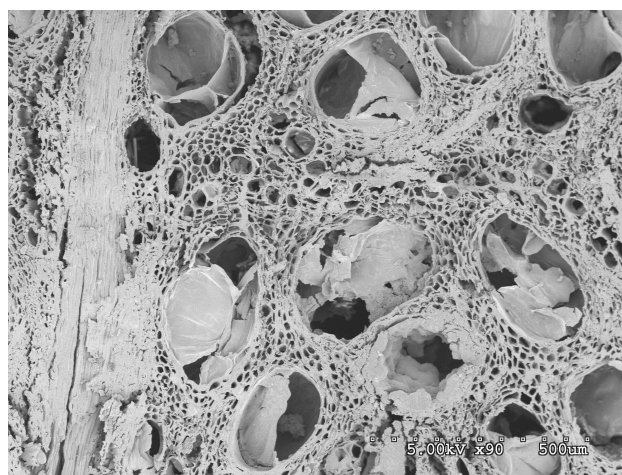
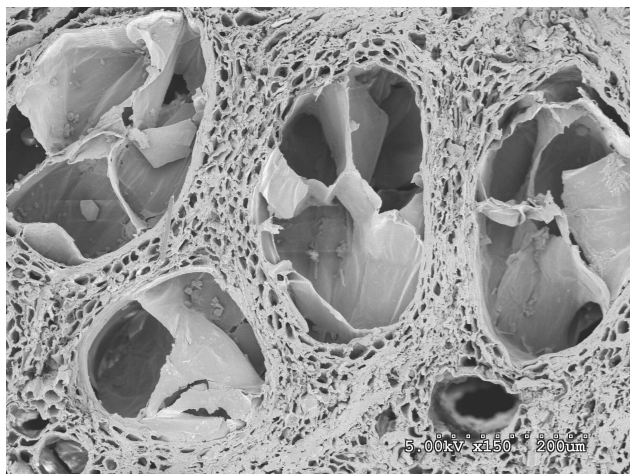
FIGURE 4-88.

Quercus petraea, BAT 6161, strake 1. Scanning electron microscope. (a–c) Brown or soft rot on the interior surface of outer layer of hull planking. (d–e) Exterior surface of inner layer of hull planking. Micrographs by Robert A. Blanchette, Department of Plant Pathology, University of Minnesota.

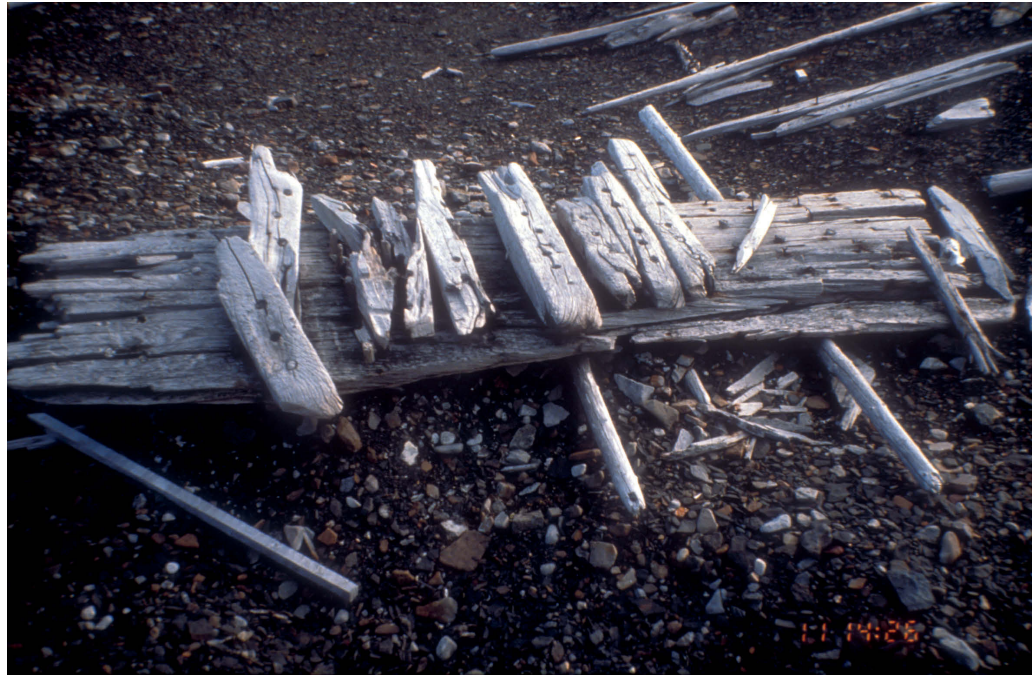
FIGURE 5-1.
Possible hull remains
of Barents' ship
(1597), Nova Zembla.
Photograph by Jerzy
Gawronski/Moscow
Institute for Heritage.

The remains of the ship's hull are 3.85 m by 93 cm and consist of two fragmented stakes of hull planking and remnants of seven floors (figs. 5-1 through 5-3). The ship's hull planking is made up of two layers, which are roughly 40 to 45 cm in width and 4 cm in thickness (for a total thickness of 8 cm); the outer layer is fastened to the inner layer with iron nails.¹⁸ The floors are fastened to the first layer of hull planking with wooden treenails. No traces of an additional layer of pine sheathing were found, although this yacht was destined to sail to the Indies. Archaeologists suspect that additional remains of

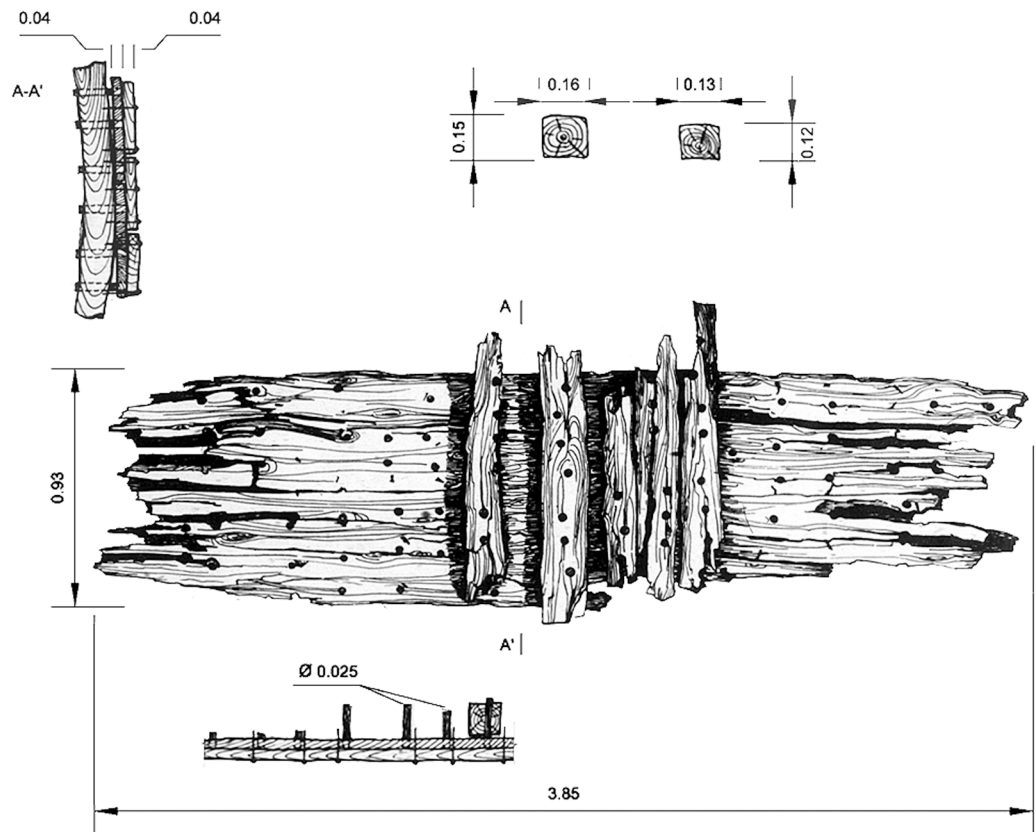
FIGURE 5-2.
Hull remains of Barents'
ship. Not to scale.
After Russian Research
Institute of Cultural
and Natural Heritage,
Moscow.

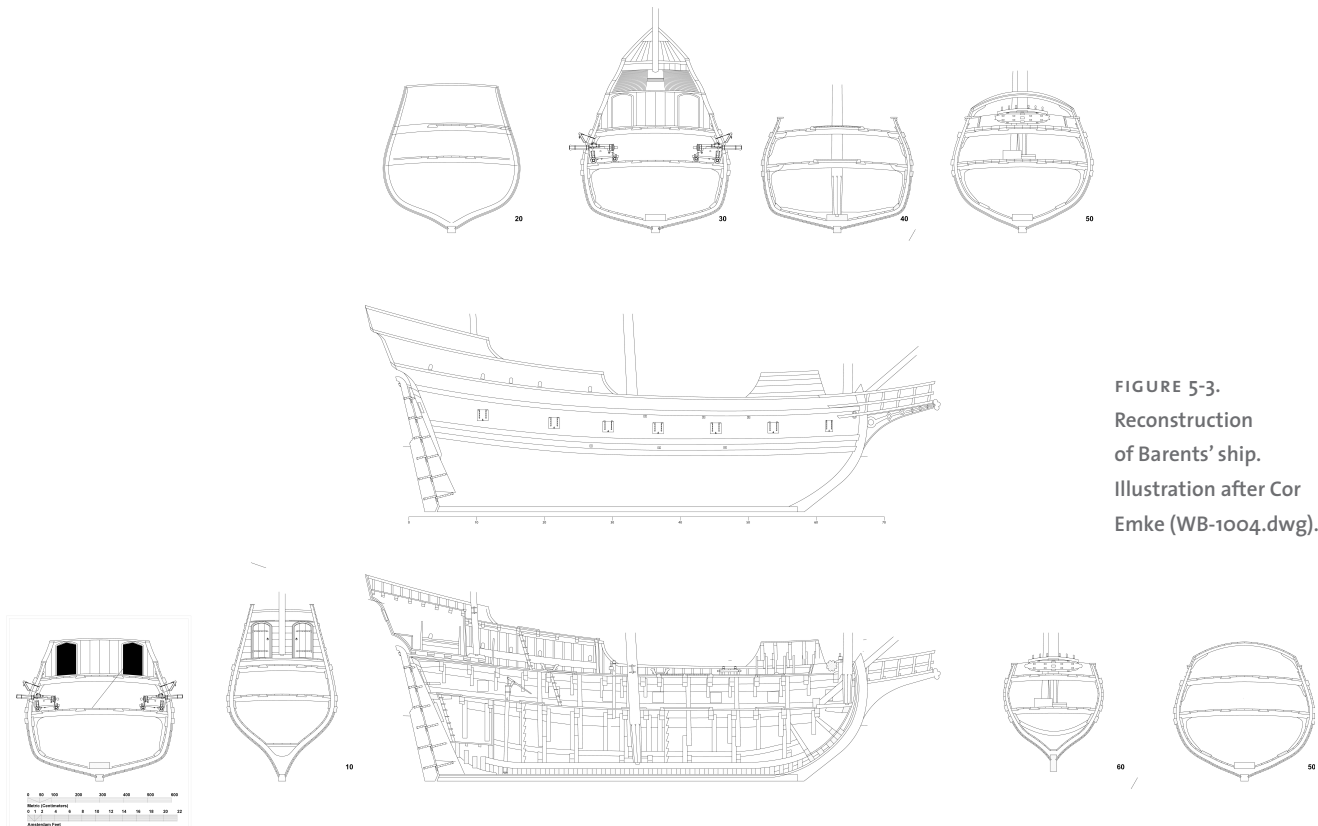
FIGURE 5-3.
Reconstruction
of Barents' ship.
Illustration after Cor
Emke (WB-1004.dwg).

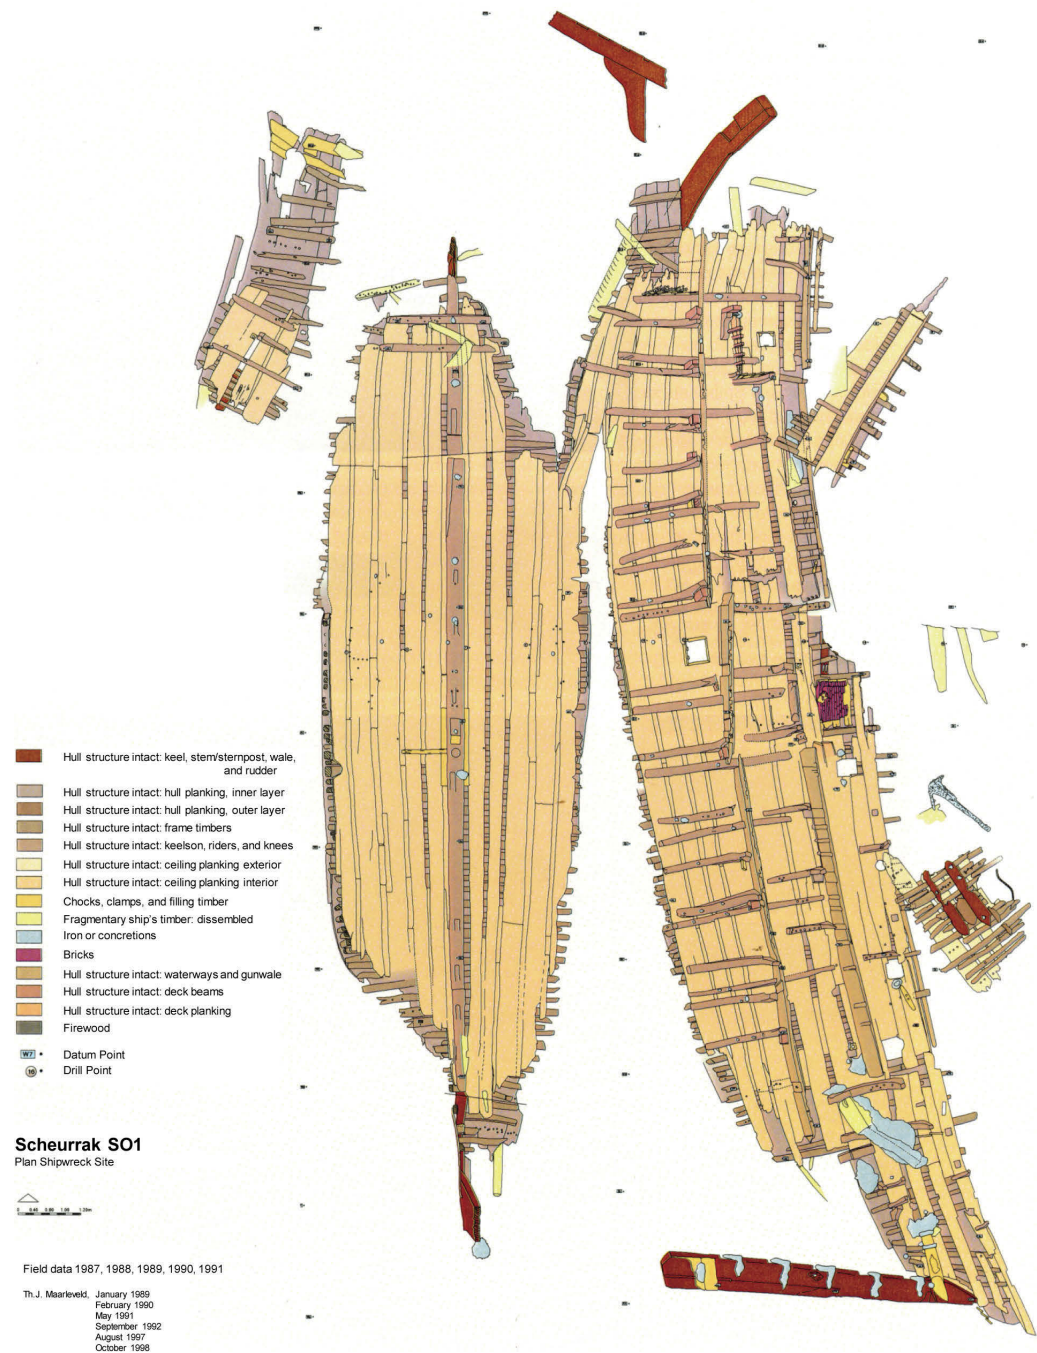
FIGURE 5-4.
Site plan of Scheurrak
SO1 shipwreck, Wadden
Sea. Illustration by Thijs
J. Maarleveld, courtesy
of the Rijksdienst voor
het Cultureel Erfgoed
(Lelystad).

The hull is well preserved and includes most of the lower starboard hull up to the turn of the bilge, bottom planking, and parts of the bow and stern (fig. 5-4).²⁵ Part of the hull's starboard side, although separated from the lower hull, is preserved up to the bulwarks.²⁶ The total length of the vessel is more than 30 m (105 Amsterdam ft), which indicates the remains are of a large merchantman.²⁷ The hull consists of a double layer of oak planking. Both layers were rabbeted into the keel and have a total thickness measuring more than 14 cm (5 Amsterdam thumbs). The thickness of the two layers of planking is more or less equal (fig. 5-5). The floors and futtocks were fastened to the first layer of hull planking with wooden treenails and are not fastened to each other.²⁸ Unlike the inner layer of hull planking, built using a bottom-based construction method, the outer layer was added

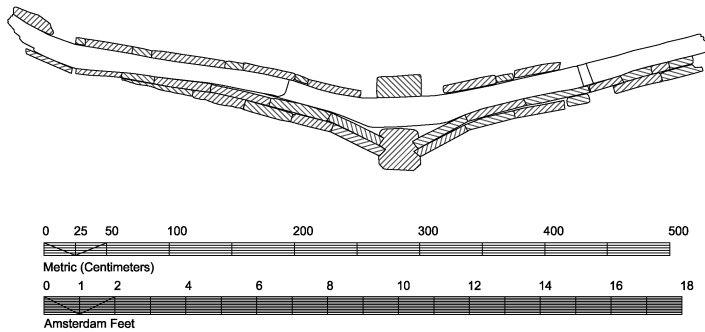
FIGURE 5-5.
Section of Scheurrak SO1 ship's
hull. Illustration after Thijs J.
Maarleveld, courtesy of the
Rijksdienst voor het Cultureel
Erfgoed (Lelystad).

after the frames were inserted. It was temporarily fastened to the inner layer of hull planking with iron fasteners (approximately two per meter) and then securely fastened in place with treenails. These treenails were wedged on the interior and pegged on their exterior surfaces.²⁹ The oak ceiling planking was fastened to the frames and the first layer of oak hull planking with wooden treenails.³⁰ The double-rabbeted keel consisted of at least three flat-scarfed timbers and has a total length of 24 m (85 Amsterdam ft).³¹

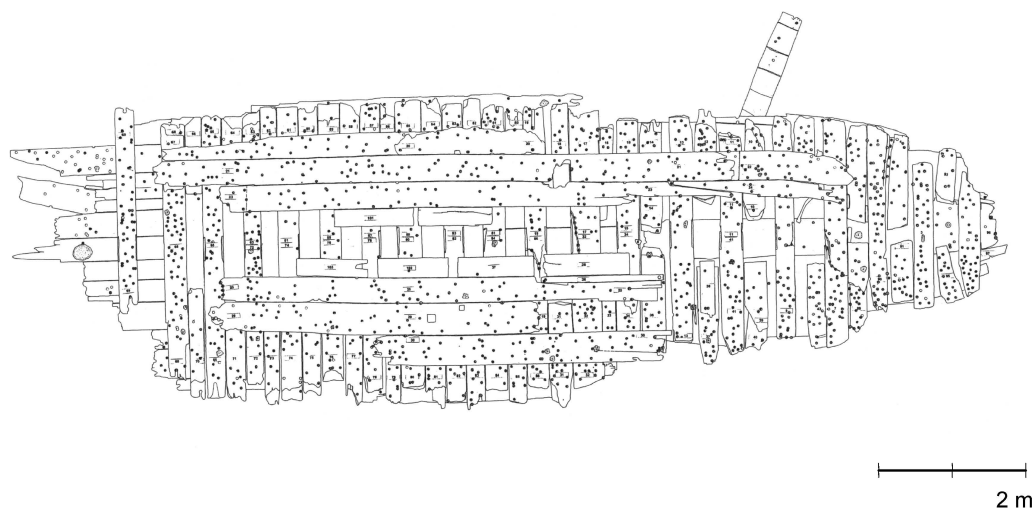
FIGURE 5-6.
Plan of the Angra C
ship's hull remains.
Illustration by Colin
O'Bannon.

Another early seventeenth-century merchantman built using a bottom-based construction method with a double layer of hull planking was found during construction of a marina in the port of Angra in the Azores. This shipwreck, named Angra C, was one of two contemporaneous shipwrecks excavated in about 7 m of water in this area by the Centro Nacional de Arqueologia Náutica e Subaquática (CNANS) in 1998. After the excavation of the Angra C and D shipwrecks was completed, their hull remains were dismantled and removed from the marina development area.⁴³ The hull remains of the Angra C were recorded and mapped under the direction of Kevin Crisman of the Nautical Archaeology Program of Texas A&M University in the summer of 2000. The structural remains of the ship were preserved over a length of 14.75 m and a width of 6 m. They include part of the ship's bottom hull and consist of the remains of the keel, keelson, rising deadwood, 6 strakes of inner hull planking and 5 of outer hull planking on the port side, 7 strakes of inner hull planking on the starboard, 20 floor timbers and 36 futtocks (18 on either side of the keel), 2 strakes of limber boards, 4 strakes of ceiling planking, and 2 bilge stringers (fig. 5-6).⁴⁴

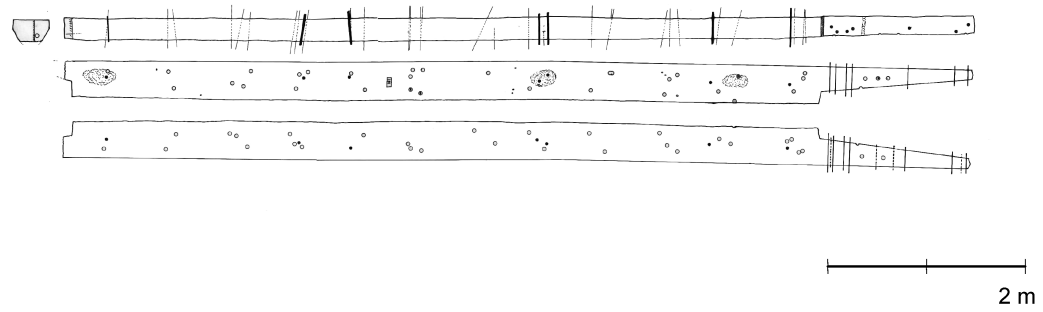
FIGURE 5-7.
Preserved keel timber,
Angra C shipwreck.
Illustration by Erik Phaneuf.

Angra C's keel was made of several timbers, only one of which was preserved. Its present length is 8.40 m, which is not its original length, as the scarf tip at its after end is only partially preserved. A reconstructed length for this keel timber is 9.85 m. At its forward end, it joined the stem with a 1.4 m vertical scarf fastened transversely with 11 metal bolts (diameter of shanks 2 cm). This keel timber has no rabbets to receive the ship's garboard strakes but has chamfered edges that correspond with the thickness of the garboard stake (7 cm; figs. 5-7 and 5-8). The keel was molded 35 cm and sided 20 cm on its top surface.⁴⁶ The endposts have disappeared. The shape of the keel is not similar to that of other shipwrecks discussed here and is not characteristic of Dutch shipbuilding of the early seventeenth century. However, *spijkerpennen* found on the top of Angra C's keel and on the ship's hull planking indicate the ship was assembled by a bottom-based construction method.

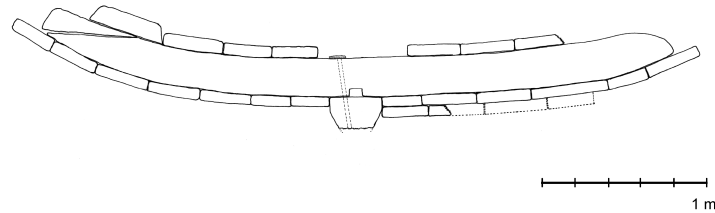
FIGURE 5-8.
Cross section showing
inner and outer layers
of hull planking, Angra
C shipwreck. Illustration
by Erik Phaneuf.

The hull consists of a double layer of planking, which is preserved only on the ship's port side. Both layers of planking have a total thickness of approximately 14 cm (5 Amsterdam thumbs). As in the Barents, Scheurrak SO1, and Christianshavn B&W 2, the thickness of the two layers of hull planking is more or less equal (7 cm; see fig. 5-8).

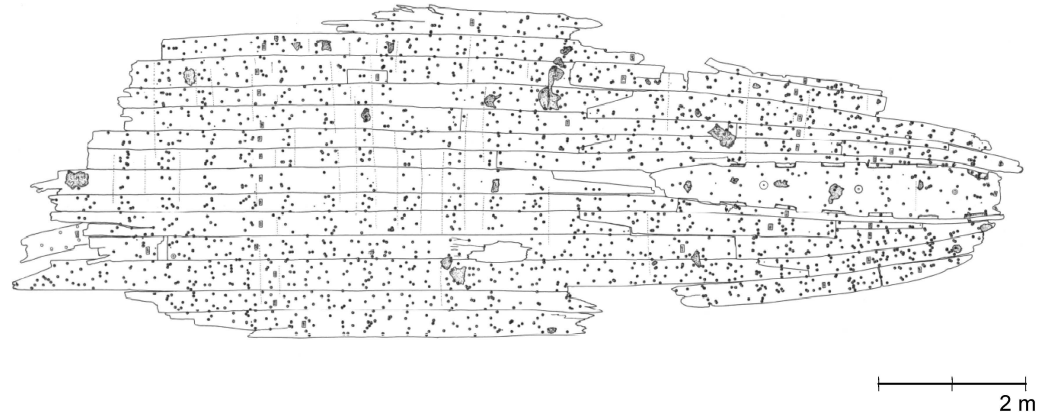
FIGURE 5-9.
Plan of inner layer of
hull planking, Angra C
shipwreck. Illustration
by Erik Phaneuf.

The inner layer of hull planking has been preserved on either side of the keel (six strakes on port, seven on starboard). The planks vary in width between 25 and 50 cm, and in thickness between 6 and 8 cm. The only complete plank with a flat scarf on either end is 11 m long (strake 4 on the port side). The ends of the hull planking were joined together with flat scarfs or butt joints, although the latter predominate on the outer layer of hull planking (figs. 5-9 and 5-10). Planks were fastened to the frames with treenails with

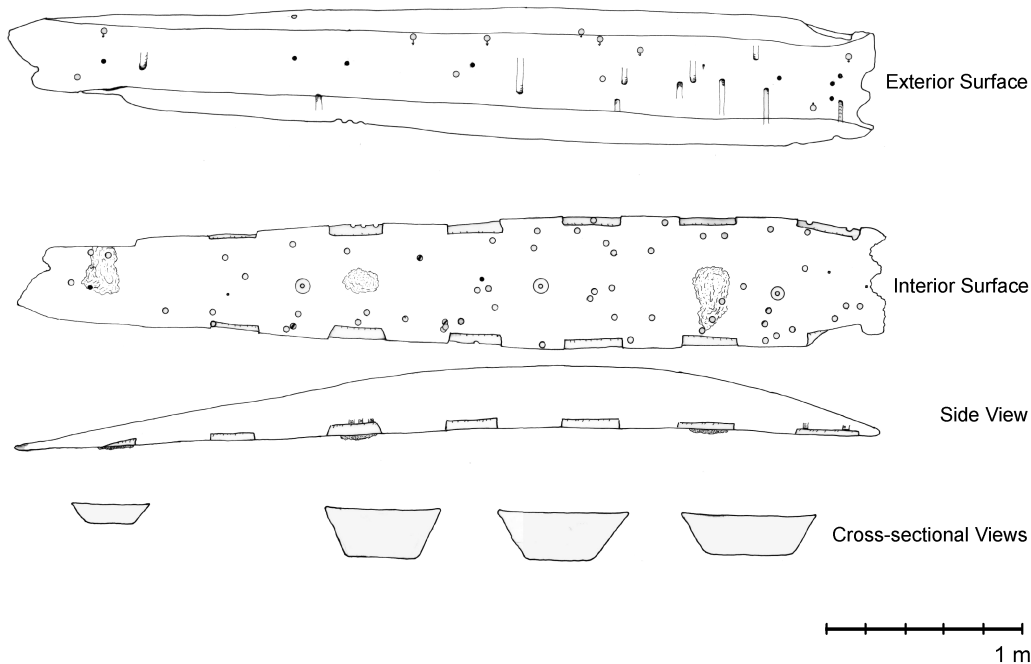
FIGURE 5-11.
Rising deadwood, Angra
C shipwreck. Illustration
by Erik Phaneuf.

deadwood with iron bolts. The first seven frames from the bow were seated in notches in the rising deadwood. This substantial timber measures 4.75 m in length and 75 cm in width and had a maximum thickness of 37 cm (fig. 5-11).⁴⁸

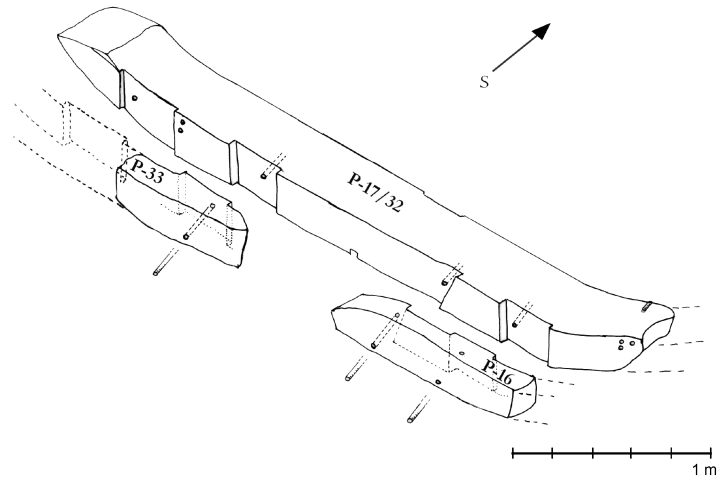
FIGURE 5-12.
Pre-assembled frame, floor
12 from the stern, Angra C
shipwreck. Illustration by Erik
Phaneuf.

Most floors and futtocks, like those of *Batavia* and Scheurrak SO1, are not fastened to each other but to the hull planking with wooden treenails. Two floor timbers, however, were joined to the futtocks with two lateral treenails, in addition to being securely locked with dovetail joints on the side of the timbers (floor 4 from the stern and 12 from the bow; figs. 5-12 and 5-13). Frame 12 had a double dovetail joint: the dovetail mortises were cut from the forward side of the floor timber, and the fixed dovetail tenons from the side of the futtock. The fixed dovetail tenon of frame 4 was cut from the aft face of the floor timber.⁵⁰

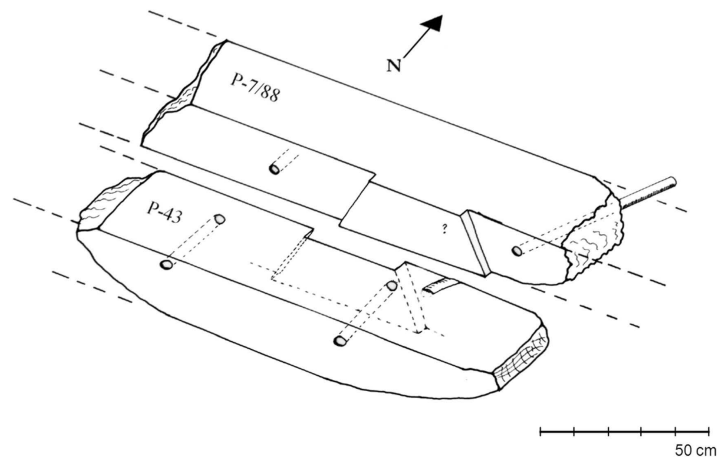
FIGURE 5-13.
Pre-assembled frame, floor
4 from the bow, Angra C
shipwreck. Illustration by Erik
Phaneuf.

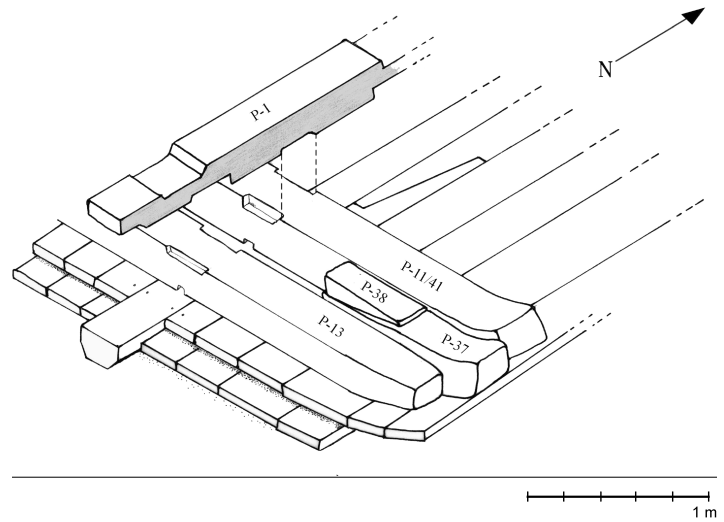
FIGURE 5-14.
Reconstruction of keel-floor-
keelson assembly, Angra C
shipwreck. Illustration by Erik
Phaneuf.

All floors had a central limber hole and were notched on the top of one or both sides to receive the keelson (fig. 5-14). A small fragment of the keelson was found underneath the ship's hull remains and was preserved over a length of 2.4 m. It averaged 34 cm sided. The lower end of the keelson is notched to fit over the ship's floor timbers and fastened to the floors with wooden treenails and iron nails. Its four preserved notches fit over frames 13–16 (counted from the vessel's stern).⁵¹

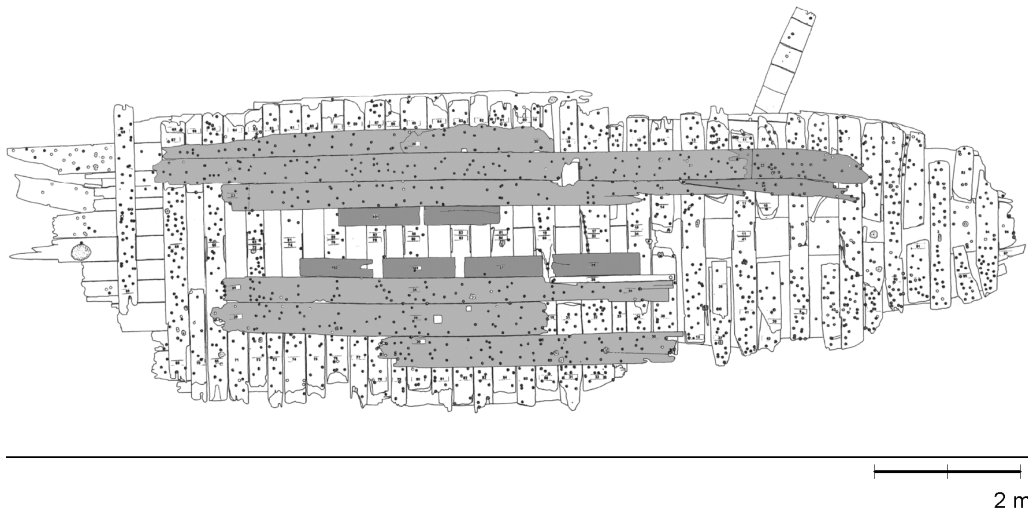
FIGURE 5-15.
Ceiling planking and
bilge stringers, Angra C
shipwreck. Illustration
by Erik Phaneuf.

of ceiling planking and a bilge stringer. The two strakes of ceiling planking were fastened to the frames with wooden treenails and iron nails (fig. 5-15). The ceiling has the same thickness as the hull planking (averaging 7 cm) and varies from 32 to 45 cm in width. The starboard stringer has a maximum preserved length of 4.4 m, is 45 cm in width, and is 12 cm in thickness. The port stringer and the first fixed ceiling strake indicate that the extremities of the ceiling planking were joined together with diagonal scarfs, whereas the planking of the second permanent ceiling strakes shows the use of a butt joint.⁵²

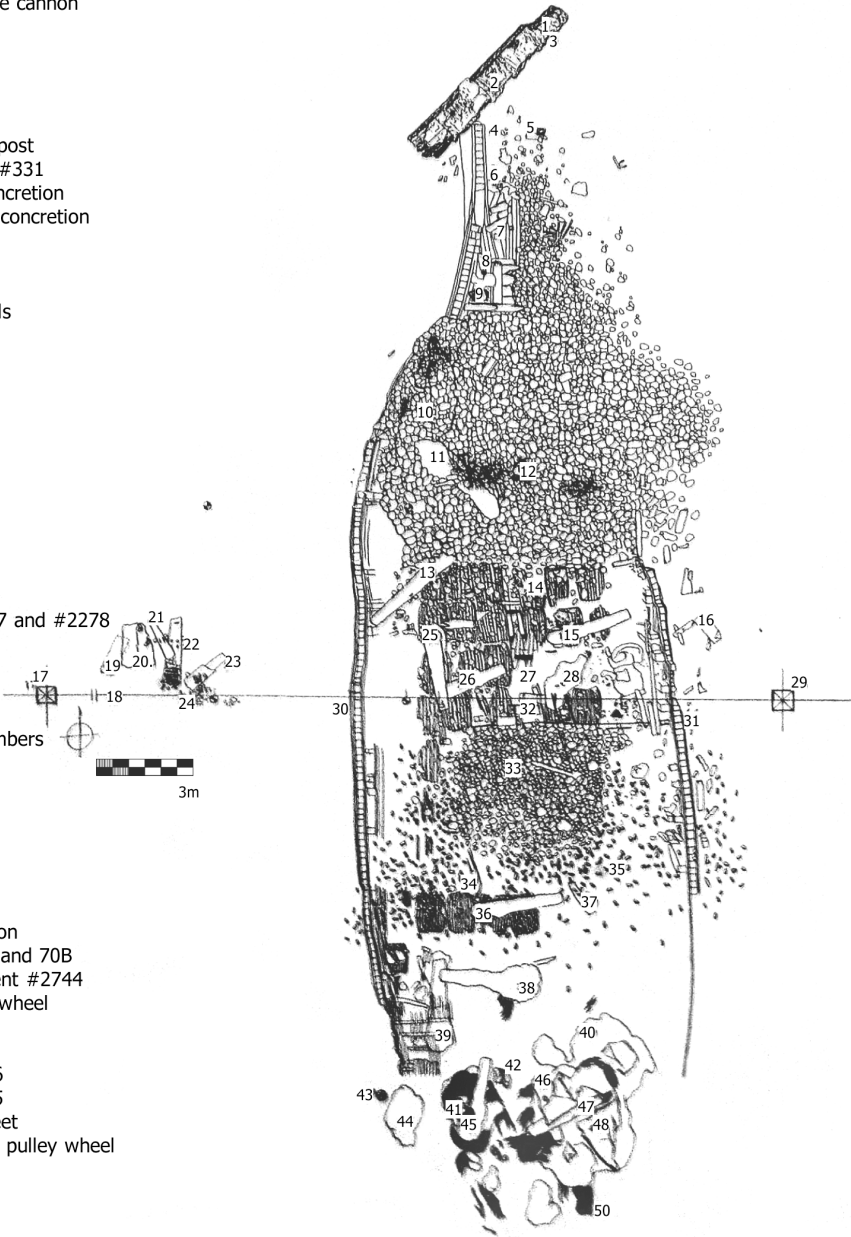
**FIGURE 5-16.**

Site plan of *Nassau* shipwreck. Department of Museums Malaysia.

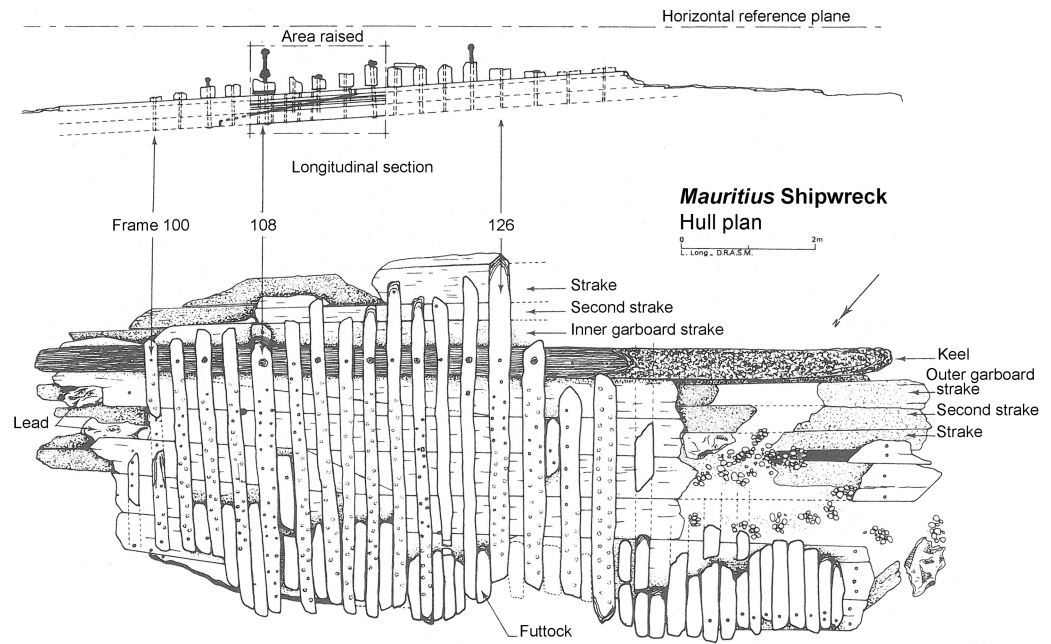
FIGURE 5-18.
Site plan of shipwreck
of Dutch East Indiaman
Mauritius. Illustration
by Luc Long and Michel
Rival, in L'Hour, Long,
and Rieth, *Le Mauritius*,
198–99. © CASTERMAN
S.A.

Of the hull structure only a small section, including 24 floors and 22 futtocks, is preserved, which measures 13 to 15 m in length and 4 to 6 m in width (fig. 5-18).⁸³ The floors are consistently 30 cm molded at the keel. The molded dimension tapers to 25 cm about 3 m away from the keel. Their average sided dimension varies from 18 to 34 cm. The futtocks are 25 cm molded and 15 to 20 cm sided.⁸⁴ The oak floors and futtocks, like those of *Batavia* and the Scheurrak SO1, are not fastened to each other but treenailed to the hull planking. The hull planking consists of two layers of oak planks that average 14 cm in total thickness (7 cm per strake). The two layers making up the garboard strake are each 9 cm thick, and those of the second strake are 8 cm. As in *Batavia* and the Barents yacht, the outer layer of planking is fastened to the inner layer with iron spikes.

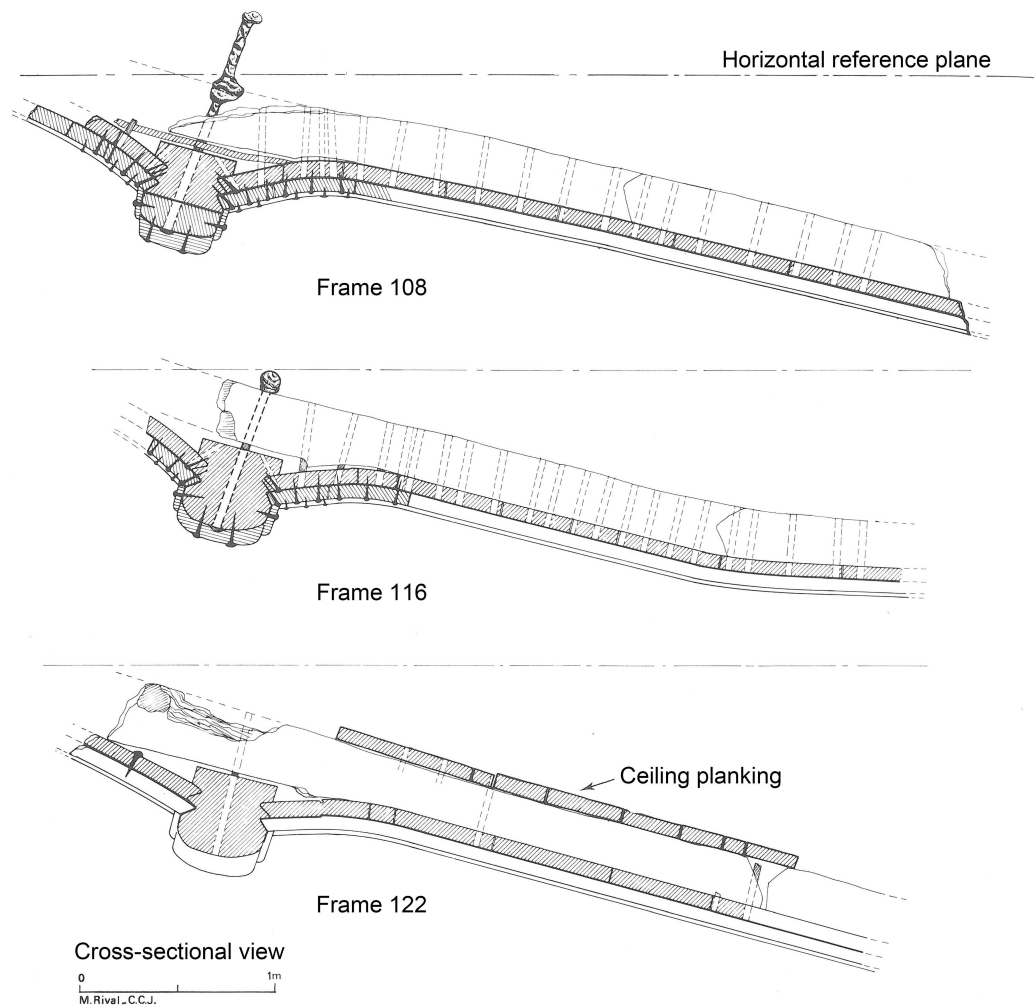
FIGURE 5-19.
Cross sections of
Mauritius's hull at
frames 108, 116, and 122.
Illustration by Michel
Rival, in L'Hour, Long,
and Rieth, *Le Mauritius*,
200. © CASTERMAN S.A.

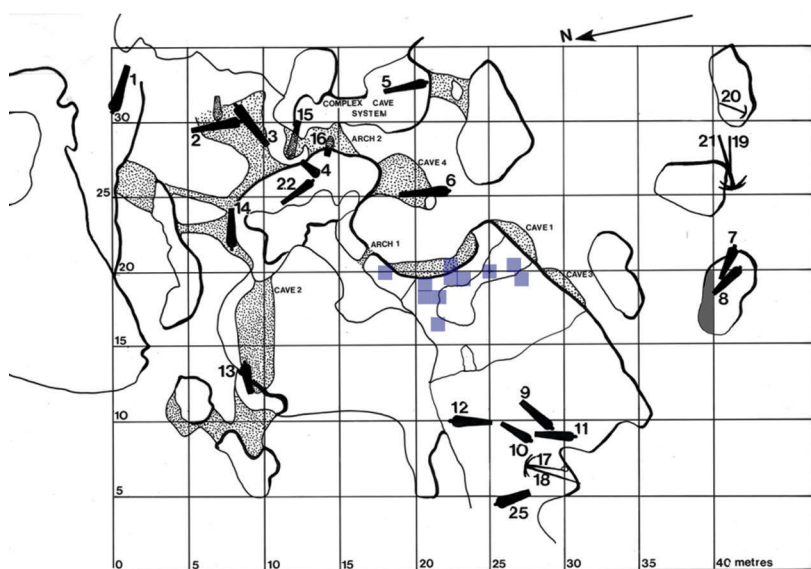
FIGURE 5-20.
Vergulde Draak
shipwreck site,
showing location
of the ship's frag-
mentary timbers in
purple. Plan after
J. Cowen, G. Brenzi,
R. Sonnerman, and
W. Anderson, 1966.

of the overhanging rocks near Cave 1 and Cave 3 on the site (fig. 5-20).⁹⁶ *Vergulde Draak's* preserved hull remains were so sparse and disarticulated that they were not recorded in situ, and initially no attempts were made to study and reconstruct them. Nonetheless, the numerous fragments raised during all three excavation seasons have been conserved (fig. 5-21).

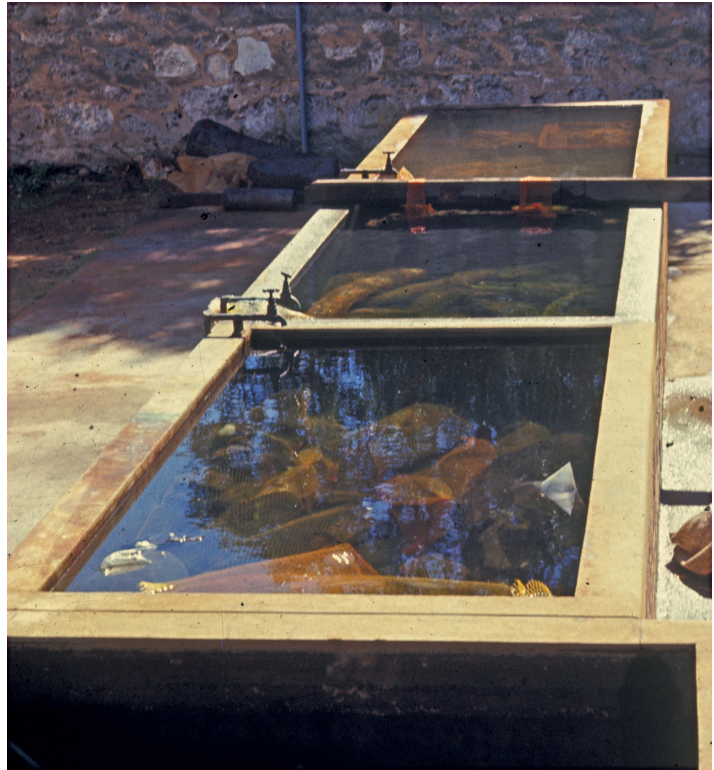
FIGURE 5-21.
Vergulde Draak's timbers in
 conservation desalination
 tank after shipwreck's
 first excavation, May 1972.
 Photograph by Patrick Baker,
 Western Australian Museum.

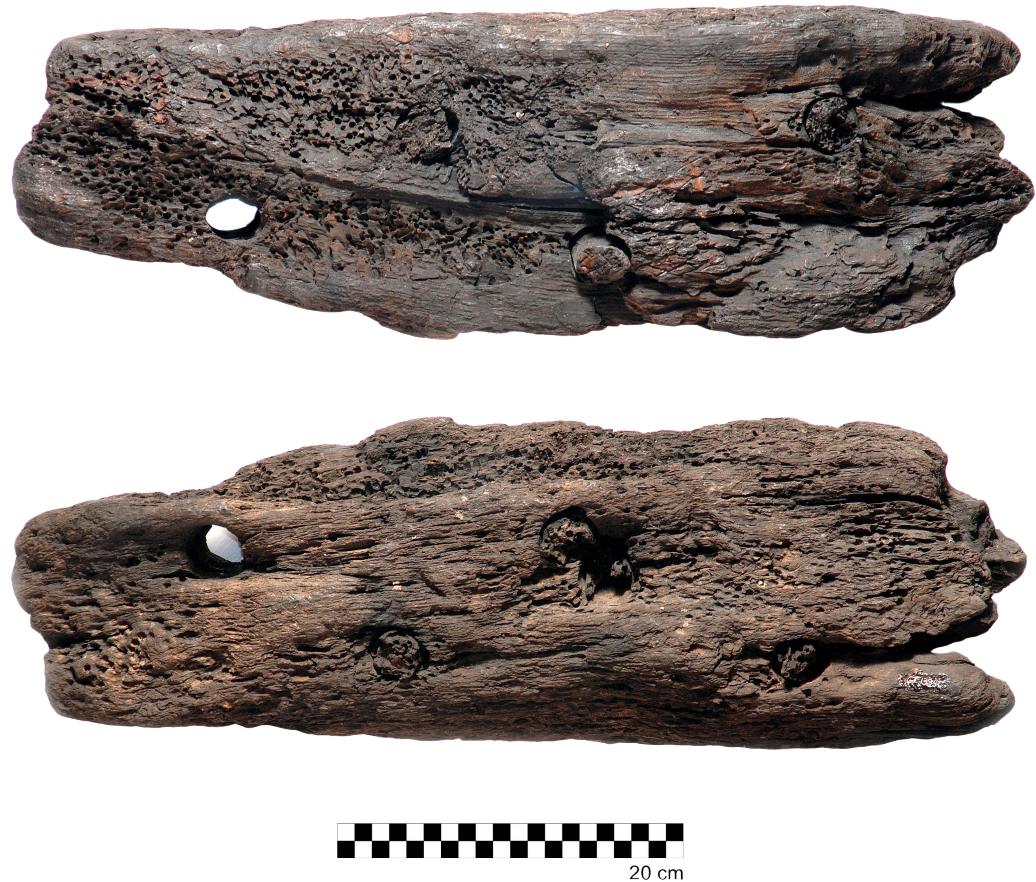
FIGURE 5-23.
Fragment of frame
wood from VOC ship
Vergulde Draak, GT
1386 P. Photograph by
Patrick Baker, Western
Australian Museum.

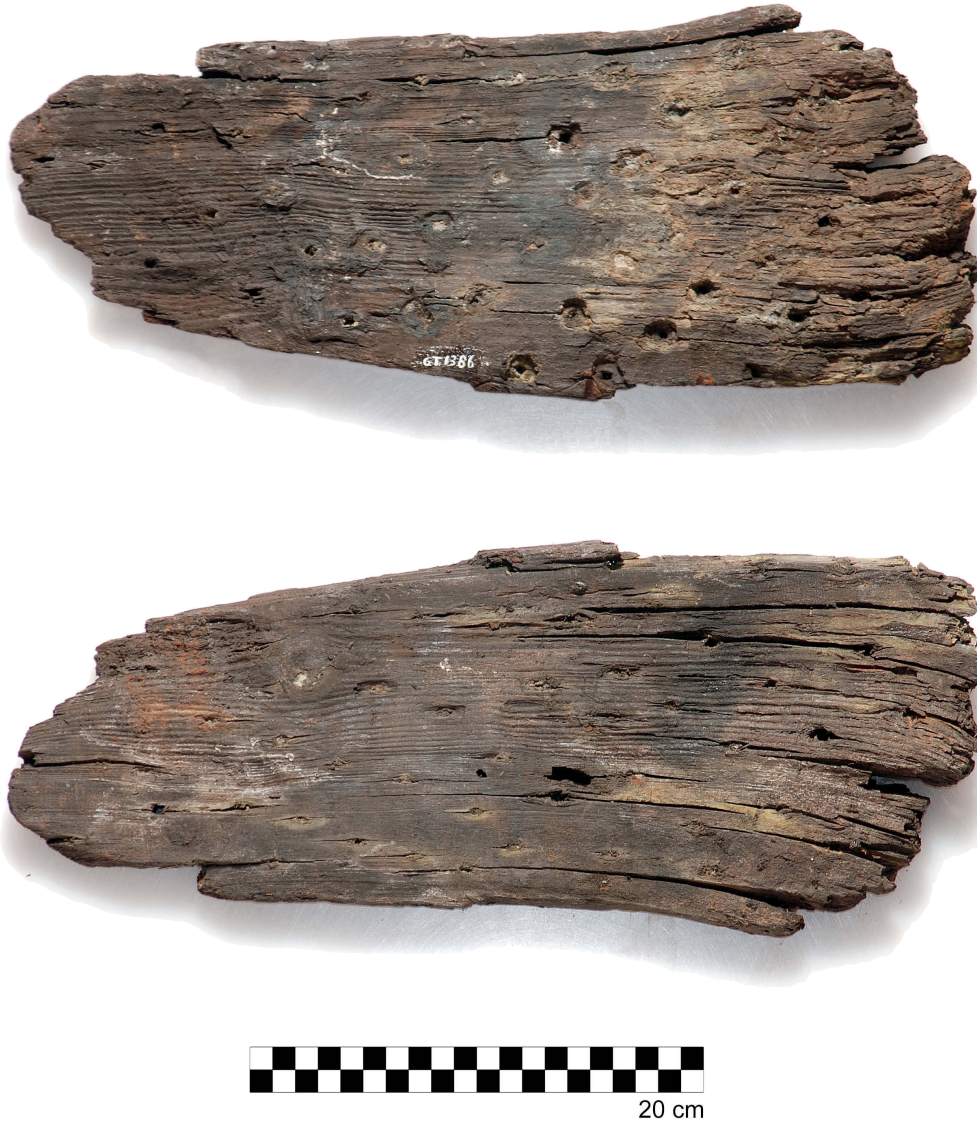
FIGURE 5-24.
Fragment of pine
sheathing from VOC
ship *Vergulde Draak*, GT
1386 L. Photographs by
Patrick Baker, Western
Australian Museum.
